Inspection Report

Minerals Regulatory Program

Mine Name: Strawberry River Quarry
Operator or Permittee Name:
Rock-It Stone Workd
Permittee Mailing Address:
P. O. Box 538, Heber City, UT 84032-0538

Permit number: S/013/008
Inspection Date: October 19, 2004

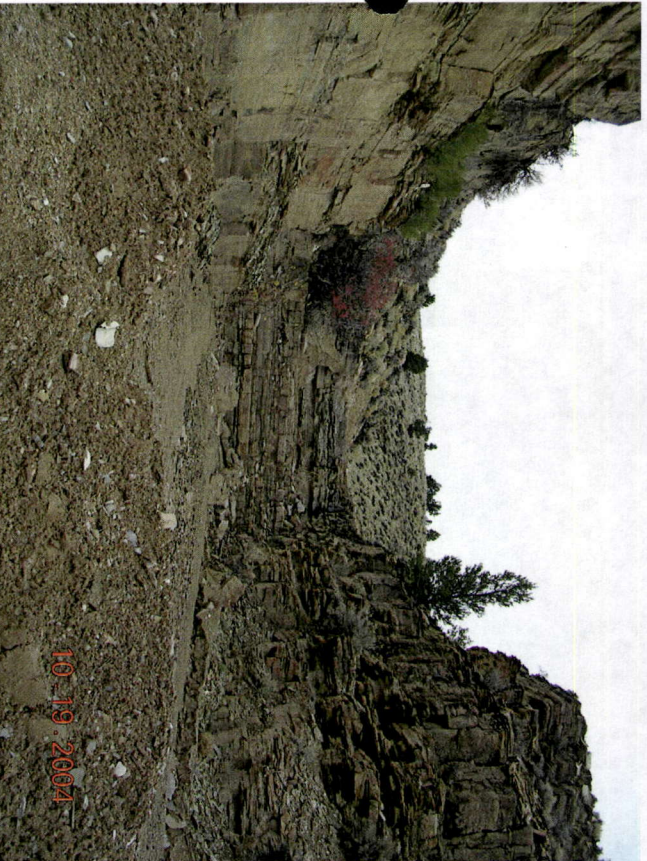
Mr. Peatross told me he had cleaned out most of the fill in the drainage to the west of the stone quarry and that any remaining material had been washed out as the result of runoff from a heavy rain. Based on our observations, this appeared to be the case (Photo 1). It looked like some of the material that had been placed in the drainage washed out on to the road and placed to the north of the road when it was cleared. Some remained behind the berm shown in the photo. It is possible some of this fill went into the Strawberry River, but this was not clear.

Photo 1. Drainage to the west of the quarry. To make a ramp to access the upper part of the quarry, fill had been placed against the escarpment in the center of this photo. The operator said he had removed most of the fill, and the rest was washed out by runoff from a large storm. The berm in the foreground is right next to the county road.

The operator submitted a revised Notice of Intention to Commence Small Mining Operations but did not include right of entry for the area of the drainage. Since this area has now been reclaimed, it can be left outside the permitted area.
